# Full mouth Rehabilitation: A Case Report

Department of Pedodontics  
Annoor Dental College and Hospital, Muvattupuzha

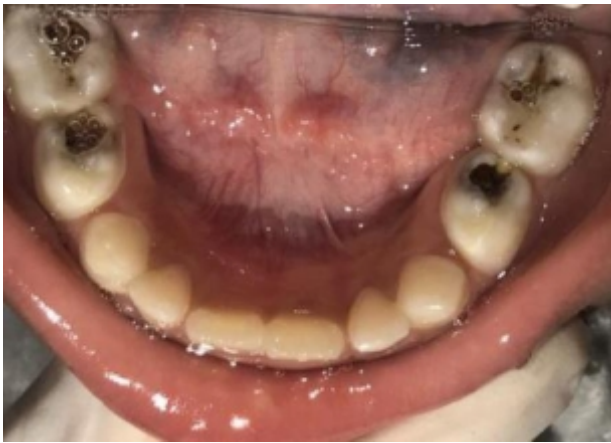
Fig 1: Preoperative photograph showing decay on 84,85,74,75, 54, 55, 63, 64

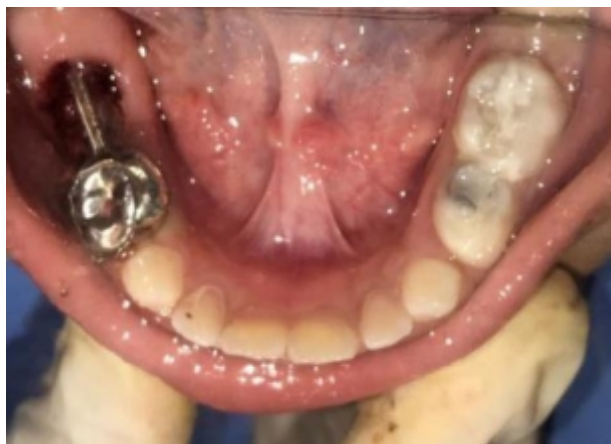
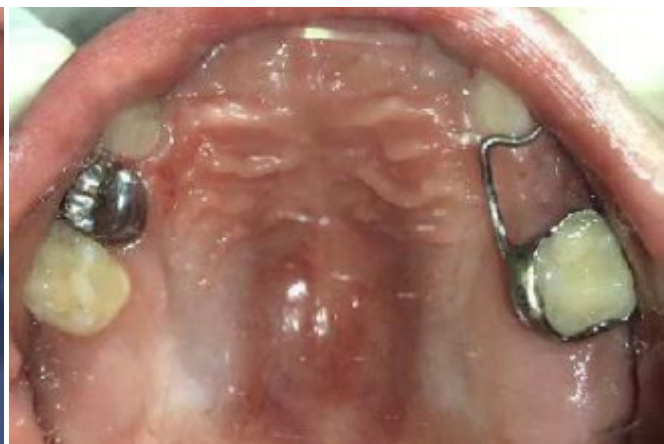
Fig 4: Post-Operative photograph showing Full Mouth Rehabilitation.

- a) 84: Pulpectomy followed by SS crown
- b) 85 : Extraction followed by distal shoe space maintainer
- c) 74,75, 63: Restoration
- d) 54 : Pulpotomy followed by SS crown
- e) 64: Extraction followed by band and loop space maintainer
